BUILDING INSPECTION REPORT

**60 Merrick Way
Coral Gables, FL 33134**

August 15, 2022

SUBJ: Commercial Building Inspections:

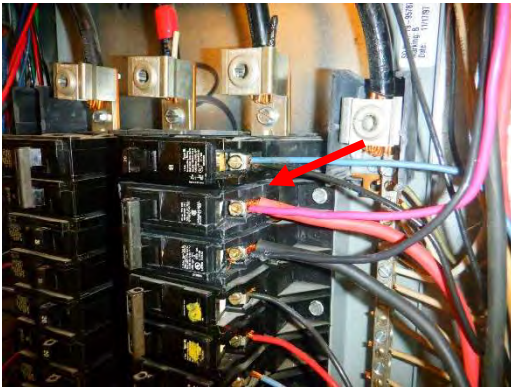
1. Panel B:
 - a. Double-tap breakers observed inside the breaker panel.
 - b. Double-tap lugs observed at the feeder lug connection.
 - c. Missing knockout cover plates observed.
2. Outlet near the prep station sink is not GFCI rated.
3. Light fixture inside the kitchen sink cleaning area is inoperable.
4. One (1) light fixture inside the men's restroom is inoperable.
5. Exit light above the main entrance is improperly wired.
6. Exit light above the south entrance is inoperable.

Double-Tap Breaker

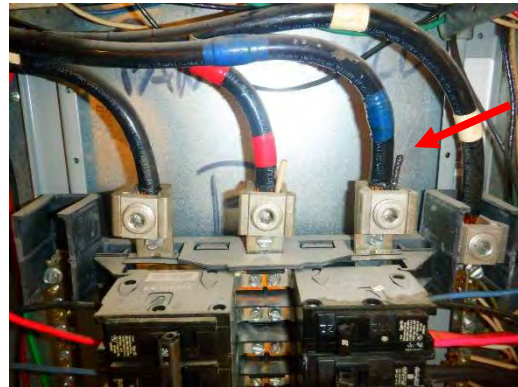
Double-Tap Lug

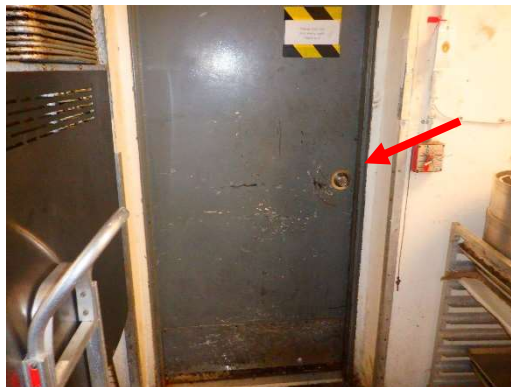
1. Front north bottom window panel is defective. Defective air gasket was observed. The formation of a foggy like image was observed at the bottom of the window.
2. Egress kitchen door hardware has incorrect unsafe type of egress door hardware. No panic hardware was noted.
3. Handicap partition wall inside the men's restroom is not properly secured. Wall mounted on the door is substandard.
4. Door leading to the women and men restroom is not installed. Door appears to have been removed from the door frame.

Incorrect Egress Hardware

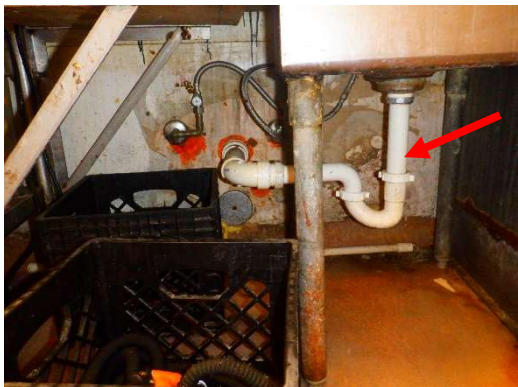
1. Interior wall for partitions housing merchandise is incomplete. Studs are exposed. Construction of the shelving of merchandise appears to be substandard. We recommend removing the partition.
2. Moisture damage observed below the prep station sink. Hidden moisture damage may exist.
3. Moisture damage observed and modifications noted to the wall below the dishwashing station/sink. Hidden moisture damage to interior wall cavity may exist.

Moisture Damage

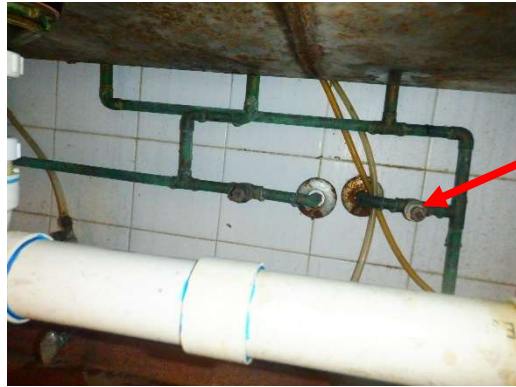
1. Office manager bathroom sink is cracked.
2. Active water leak observed below the kitchen sink.
3. Kitchen sink water stem valves for the hot and cold-water valves are missing.
4. Men's Restroom:
 - a. Wall mounted urinal is cracked.
 - b. Wall mounted sink is not properly security.
 - c. Handicap bathroom sink is cracked.
5. Women's Restroom:
 - a. Toilet is loose at the base.
 - b. Overflow plumbing line below the handicap bathroom sink is not connected.

Missing Stem Valve Handles

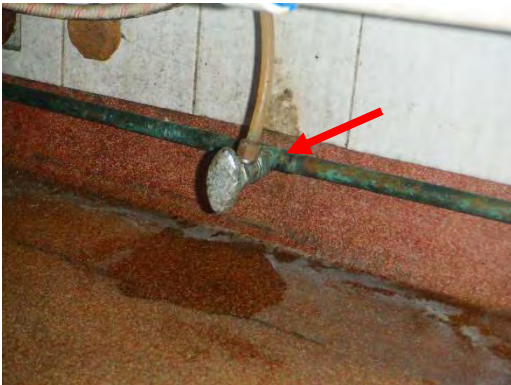
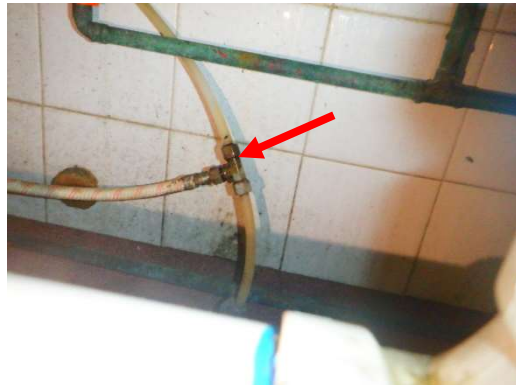
Water Leak Below Sink

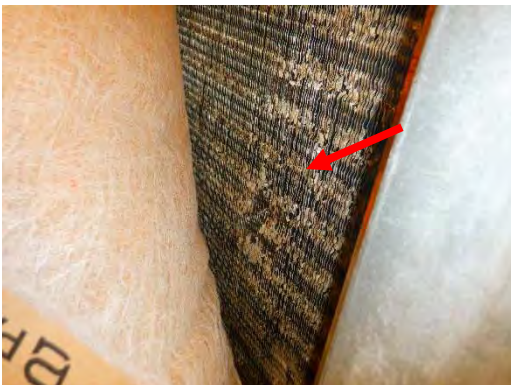
1. Unit # 1: Unit coils are brittle. We recommend monitoring performance of the equipment.
2. Unit # 2: Unit coils are brittle and damaged. Fins are bent.
3. Unit # 3: Unit coils fins are bent and bottom controls access cover plate is not properly secured. We recommend monitoring performance of equipment.
4. Cooling Tower # 1:
 - A. Exterior FRP casing vents are deteriorated and brittle. The south sector of the cooling tower vents is damaged.
 - B. Casing filler screens are brittle and packed with overgrown mildew. These conditions effect the flow of air and water.
 - C. Casing supporter and anchors are show signs of heavy corrosion.
 - D. The ladder mounted on the side of the equipment is heavily corroded. Unsafe to climb.
 - E. The interior of the equipment was not visible due to the high levels of algae growth.

Brittle Heat Pump Coils

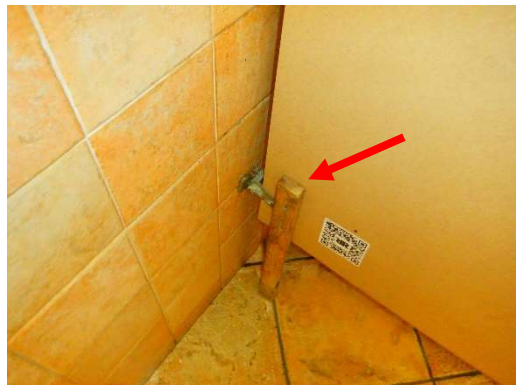
Bathroom Partition Not Secured

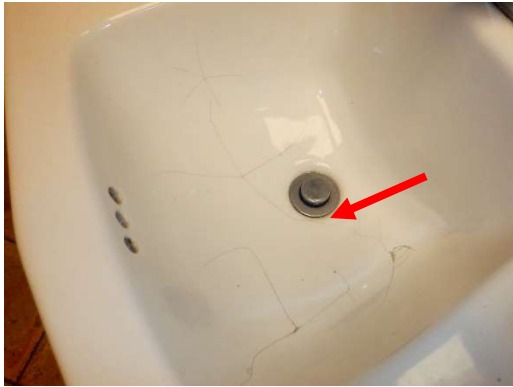
Cracked Bathroom Sink

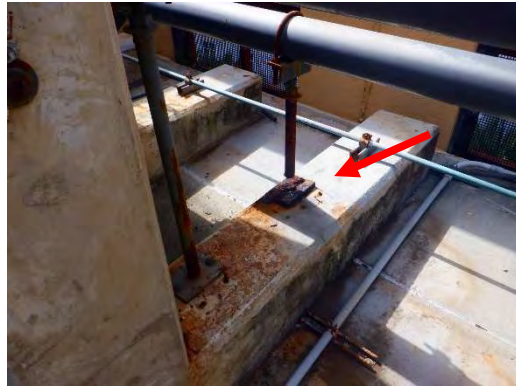
5. Chiller # 2:
 - A. Water shutter valves are corroded. Valve handle is missing.
 - B. Bottom of the FRP tank is cracked.
 - C. Chill water line pipe stands and bases are corroded to the point of replacement.
 - D. Exterior FRP casing vents are deteriorated and brittle. The south sector of the cooling tower vents is damaged.
 - E. Casing filler screens are brittle and packed with overgrown mildew. These conditions effect the flow of air and water.
 - F. Casing supporter and anchors are show signs of heavy corrosion.
 - G. The ladder mounted on the side of the equipment is heavily corroded. Unsafe to climb.
 - H. The interior of the equipment was not visible due to the high levels of algae growth.
6. Due to the above deficiencies and lack of preventative maintenance to equipment, we recommend client budget and plan for replacement, in lieu of repairs.

Corroded Pipe Stands

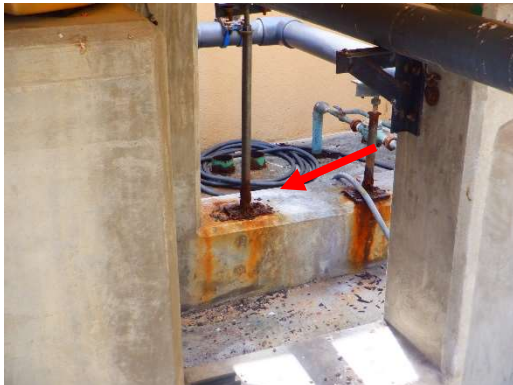
Corroded Pipe Hangers

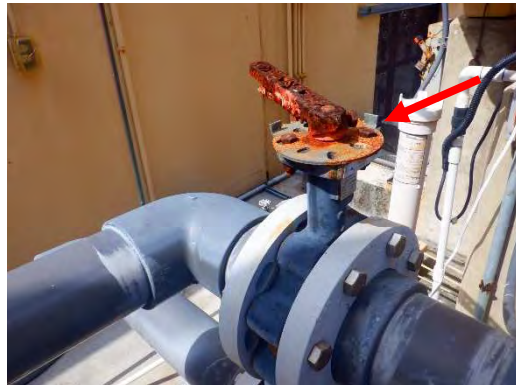
Corroded Water Valves

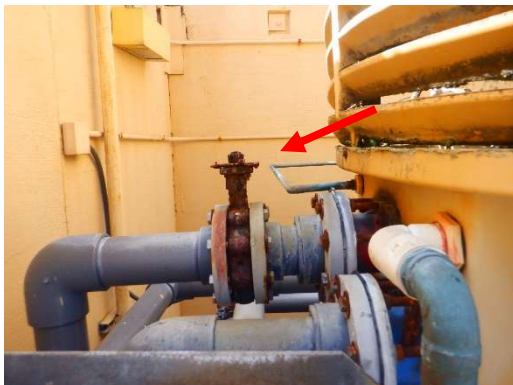
Corroded Valve Handles

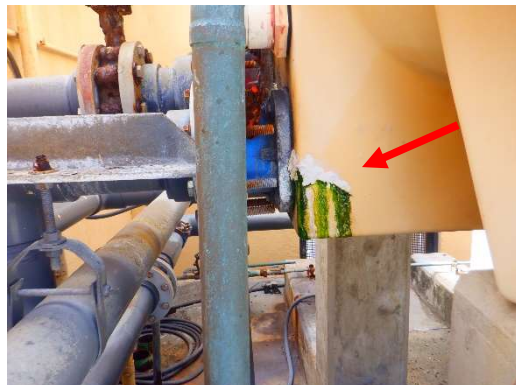
Crack Bottom of Chiller Housing

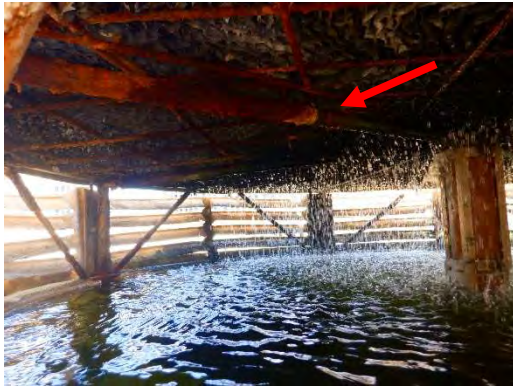
Excessive Mildew

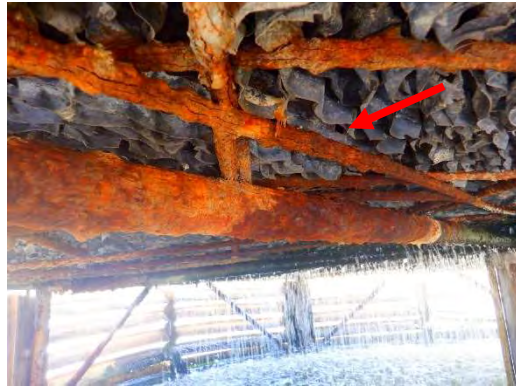
Corroded Pipe and Frame

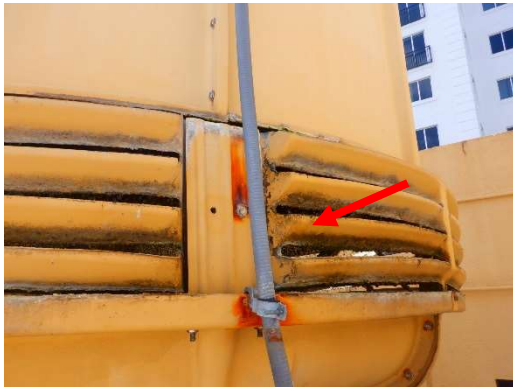
Brittle Housing

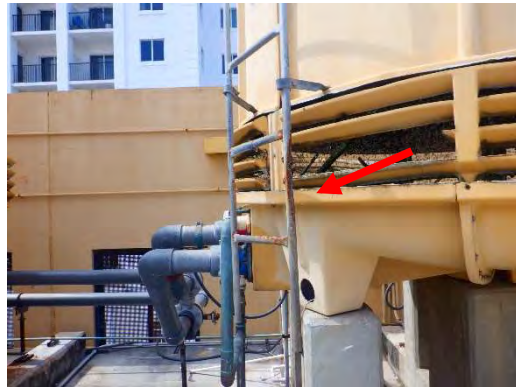
Corroded Ladder

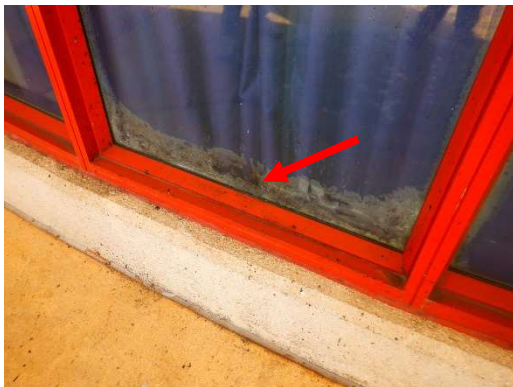
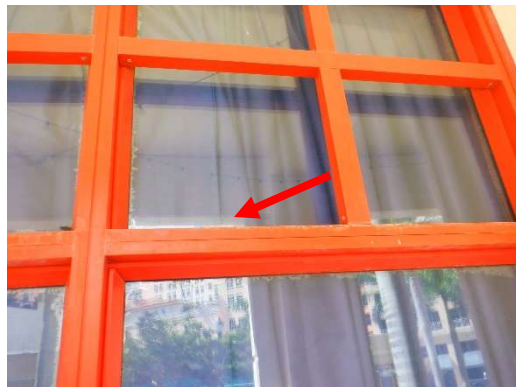
Fog Between Window
