TRUVIEW COMMERCIAL INSPECTION REPORT

60 Merrick Way
Coral Gables, FL 33134

The City of Coral Gables
SEPTEMBER 7, 2023

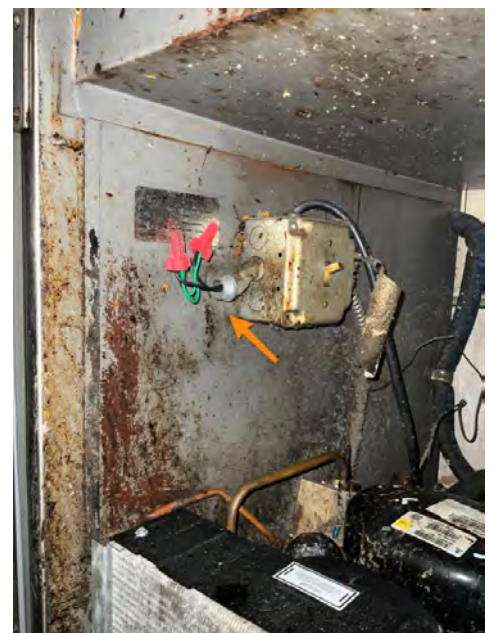
Kitchen

3.2.1 Electrical Components

EXPOSED WIRING

Exposed wiring observed at the property. A licensed electrician should be hired to make proper repairs.

Contact a qualified electrical contractor.

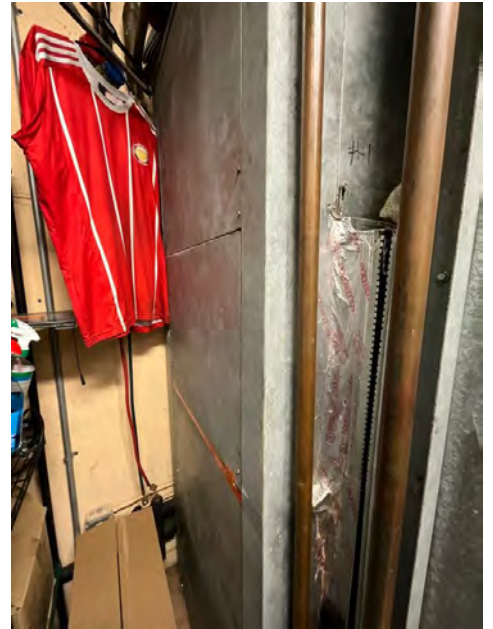
LABEL NOT LEGIBLE

Inspector is unable to determine age and size of unit due to unit identification label not being legible.

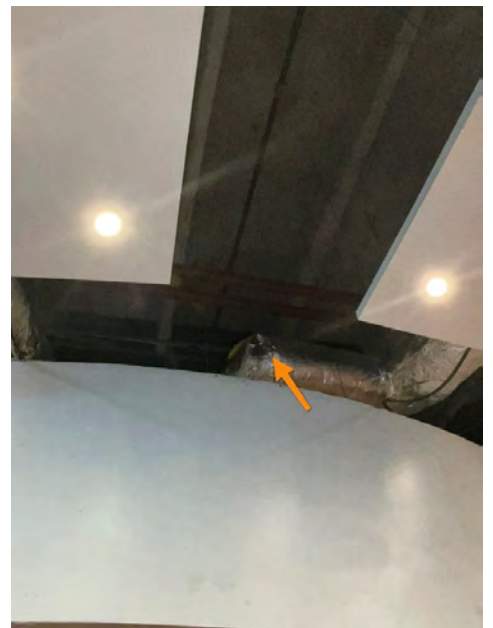
Center

4.5.1 HVAC Components

DUCTS DAMAGED

Ducts were observed to be damaged at the time of inspection; repair/replacement is recommended.

Contact a qualified heating and cooling contractor

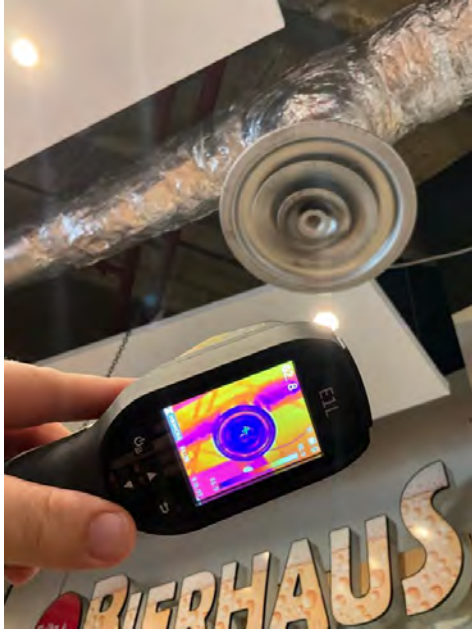
Left Bar

4.5.2 HVAC Components

TEMPERATURE OUT OF VENTS MORE THAN 60 DEGREES

The air conditioner was functional but did not produce cold enough air. Normally an A/C system must produce a minimum of 60 degrees out of the vents and in this case it did not. It is recommended that a licensed HVAC contractor evaluate **(see video attached)**.

Contact a qualified heating and cooling contractor

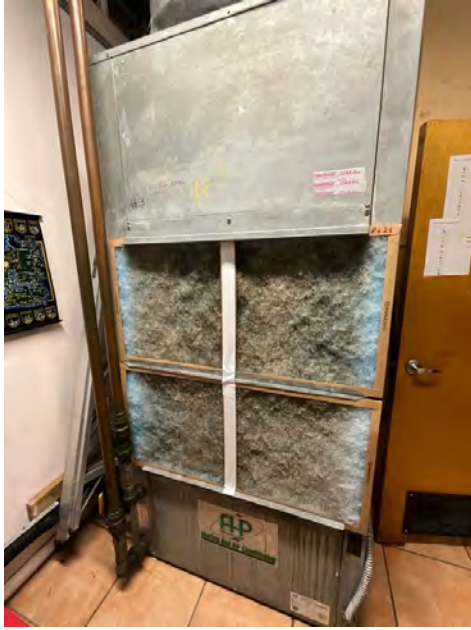
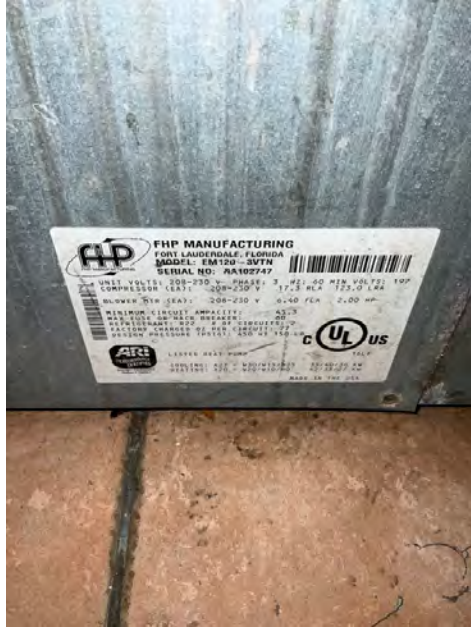
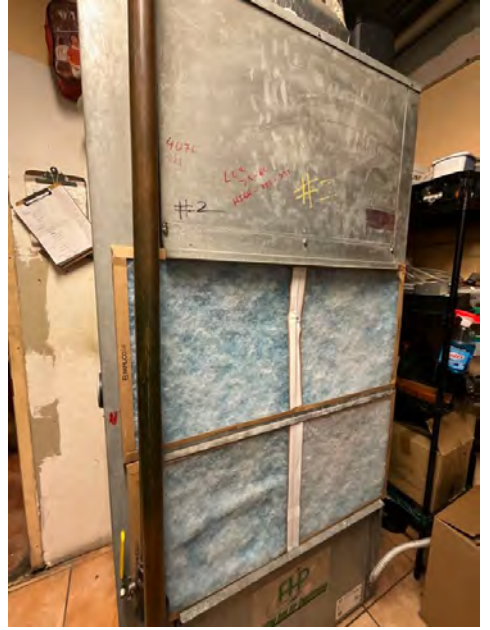
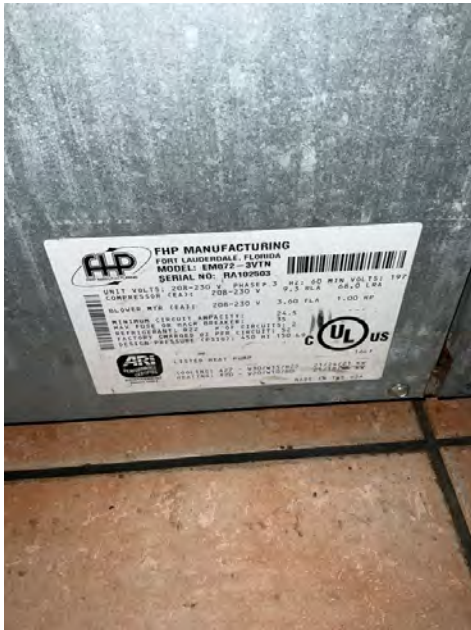
4.5.3 HVAC Components

UNIT NEAR END OF LIFE EXPECTANCY; REPLACEMENT ANTICIPATED

Air conditioning systems have an average lifespan of 12-15 years. Once a unit is in that timespan then you should anticipate replacement in the near future. Sometimes well maintained units last even longer but unfortunately we are not able to tell you how long the A/C will last.

Contact a qualified heating and cooling contractor

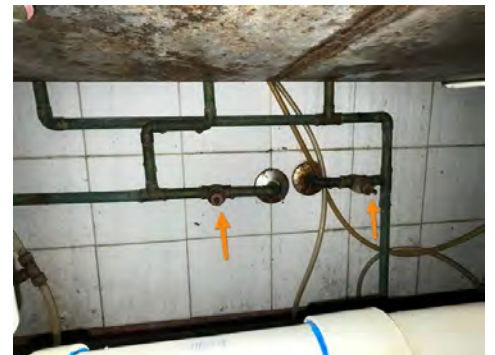
Kitchen

5.3.2 Plumbing Components

HANDLE IS BROKEN

Shut off valve handle is broken; replacement recommended.

Contact a qualified plumbing contractor.

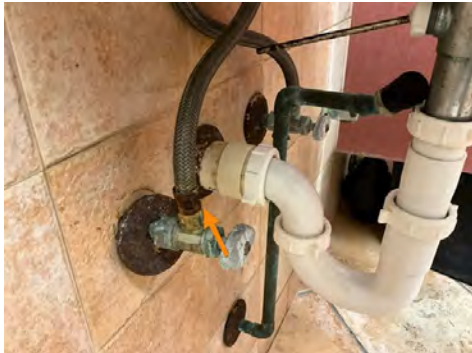
Bathroom

5.3.4 Plumbing Components

CORRODED SUPPLY PIPES

Supply pipe(s) observed corroded. This could be an indication that a leak is or was present. A licensed plumbing contractor is recommended for further evaluation.

Contact a qualified plumbing contractor.

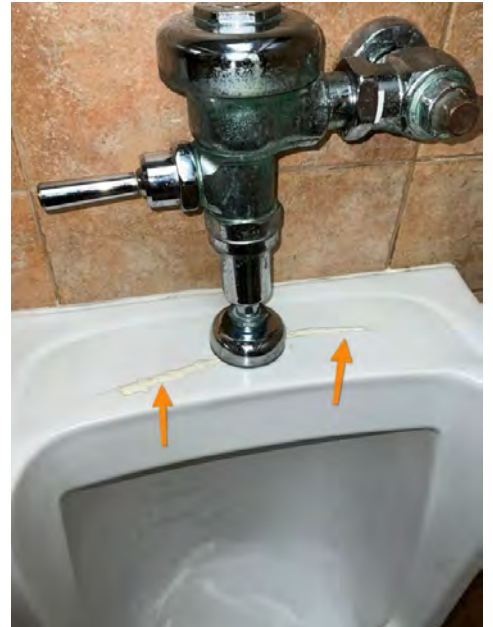
Men's Bathroom

5.3.5 Plumbing Components

CRACKED URINAL

Cracked Urinal observed.

Contact a qualified professional.

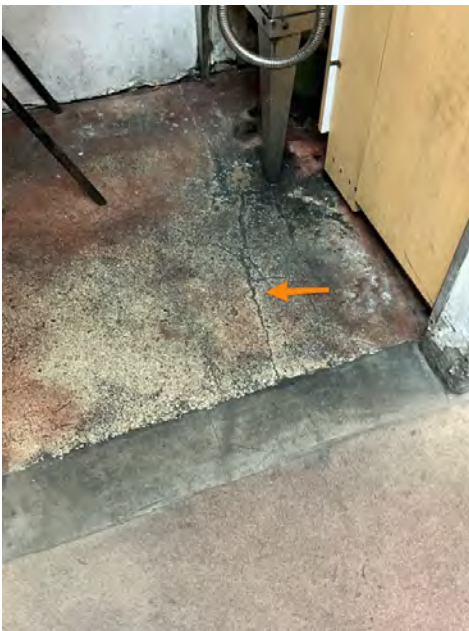
Kitchen

6.2.1 Interior Components

CRACKED TILES/FLOORS

Cracked tile/flooring are present at time of inspection; repairs are recommended.

Contact a qualified professional.

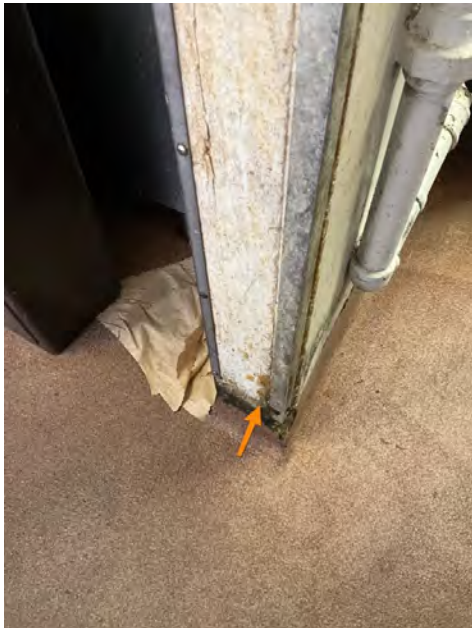
Kitchen

6.2.2 Interior Components

INTERIOR WALL DAMAGE

Damage observed on interior walls. It is recommended that a handyman/painter repair walls.

Contact a qualified handyman.

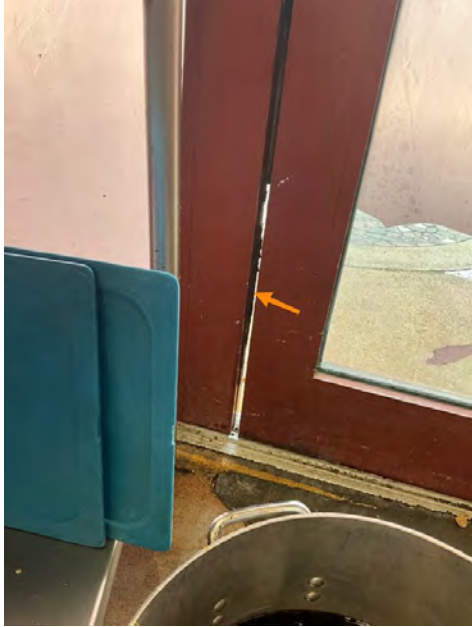
Kitchen

6.2.4 Interior Components

EXTERIOR DOOR FAILED SEAL

Exterior door failed seal.

Contact a qualified professional.
